TROUBLE SHOOTING, MICROMAX AND VVX MOTORS

Troubleshooting, MicroMax, MicroMax180, MicroMax370, MicroMax750

Connecting and troubleshooting VVX motors

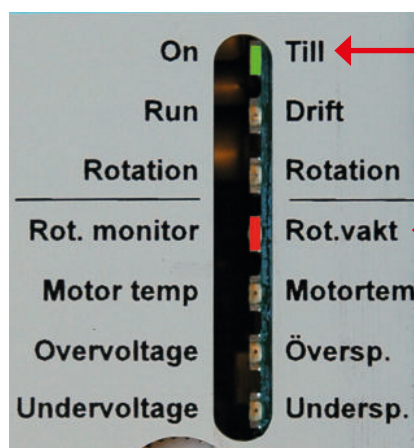
Control unit tripped due to rotation sensor

Probable cause during installation:

Magnet facing the wrong way (applies to IBC's magnetic sensor)

Magnetic sensor incorrectly connected (wrong polarity, applies to IBC's magnetic sensor) Connect the white cable to terminal 9, the Brown cable to terminal 10.

Probable cause during operation:

Broken belt

Belt slipping

Stuck wheel

Motor/Gearing damaged.
